Note on the 1.9M Slip Rings

D. Carter February 2013

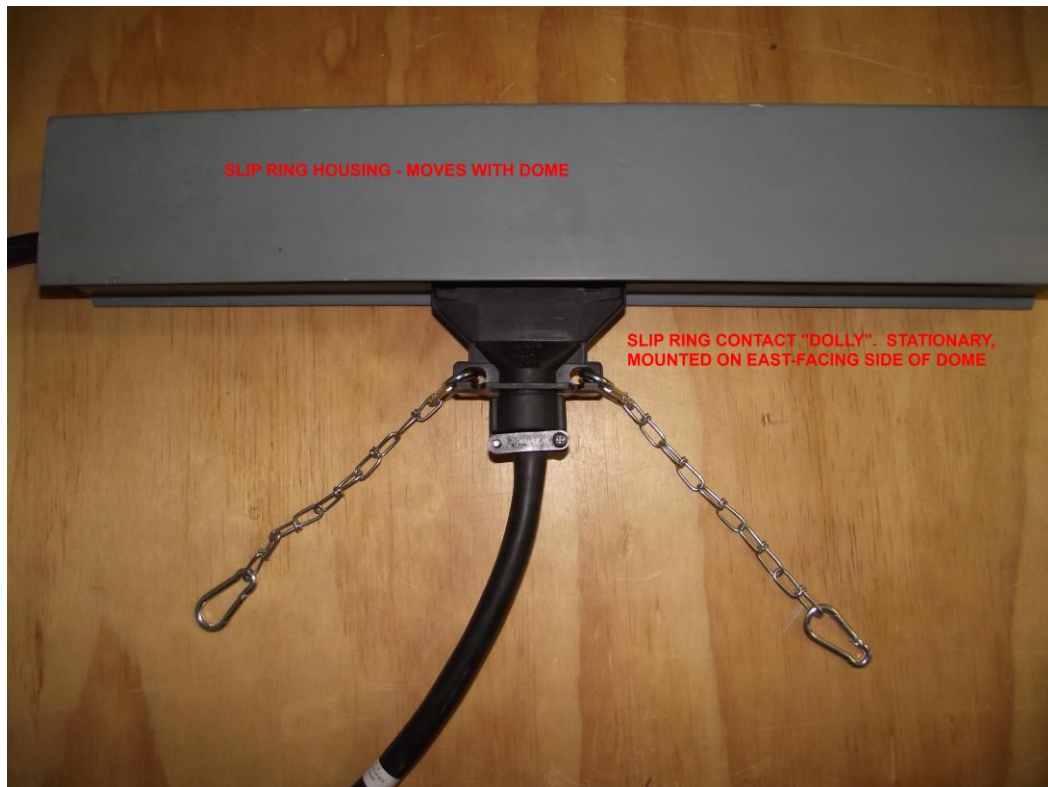
Figure 1 shows the slip ring “dolly” in a section of track. Note that the track moves with the dome and the dolly is secured and stationary on the dome wall. The two chains provide lateral support to allow the dolly some degree of freedom of movement. The dolly fits quite snugly in the track and has a number of guide wheels, such that there is very little lateral or up/down movement of the dolly inside the track

Figure 1: slip ring track with dolly inserted

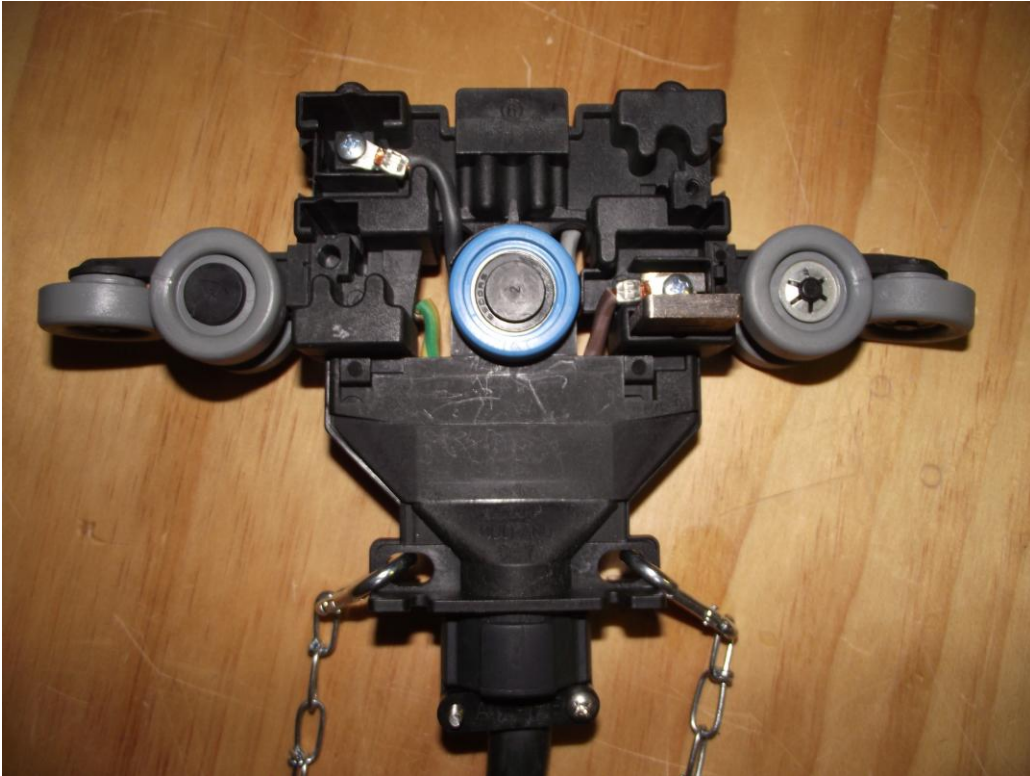
We found the slip ring dolly (figure 2) very loose – it could be moved up and down inside the track. This is the first obvious fault – figure 3 shows that there is very little play for the dolly to move laterally or up/down in the track.

Figure 2: Slip ring dolly showing guide wheels and one contact brush

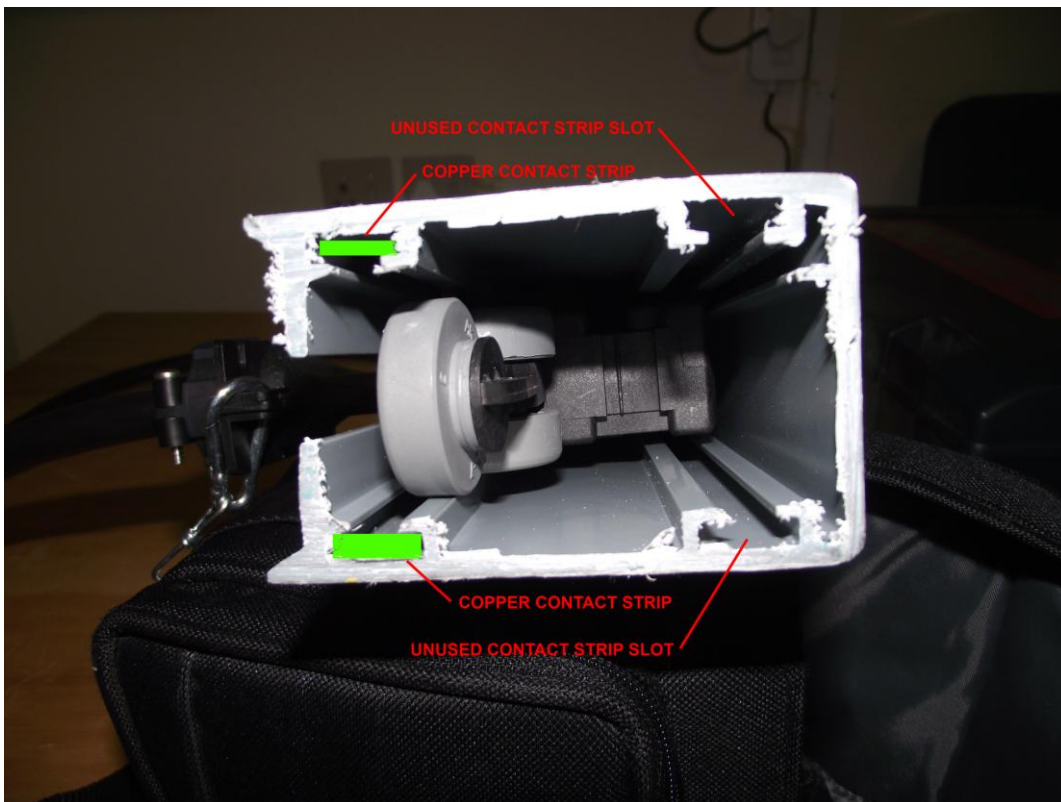
Figure 3: Dolly inside track

Figure 3 shows the dolly inside a section of track. The slots containing the contact strips are highlighted green. The track can handle four contact strips – the upper slots are not populated/used in the 1.9M installation

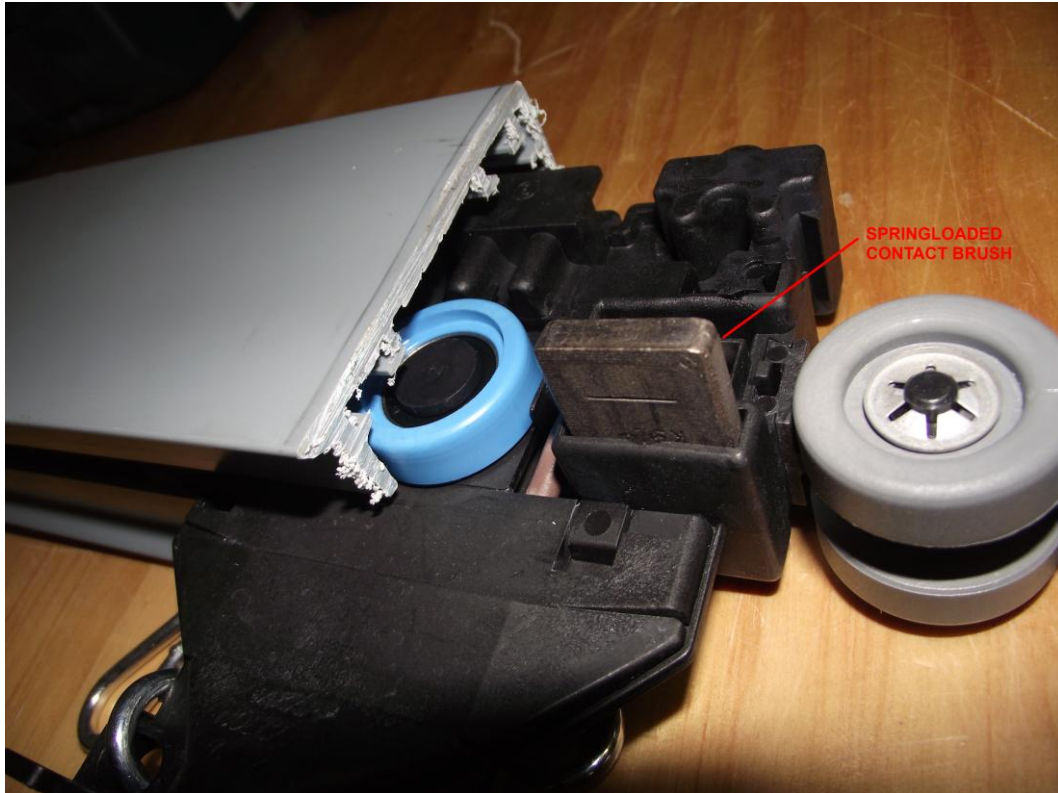
Figure 4: Dolly showing one springloaded contact.
