IRSF: Faultfinding SIRIUS Instrument detectors

Willie Koorts

March 2016

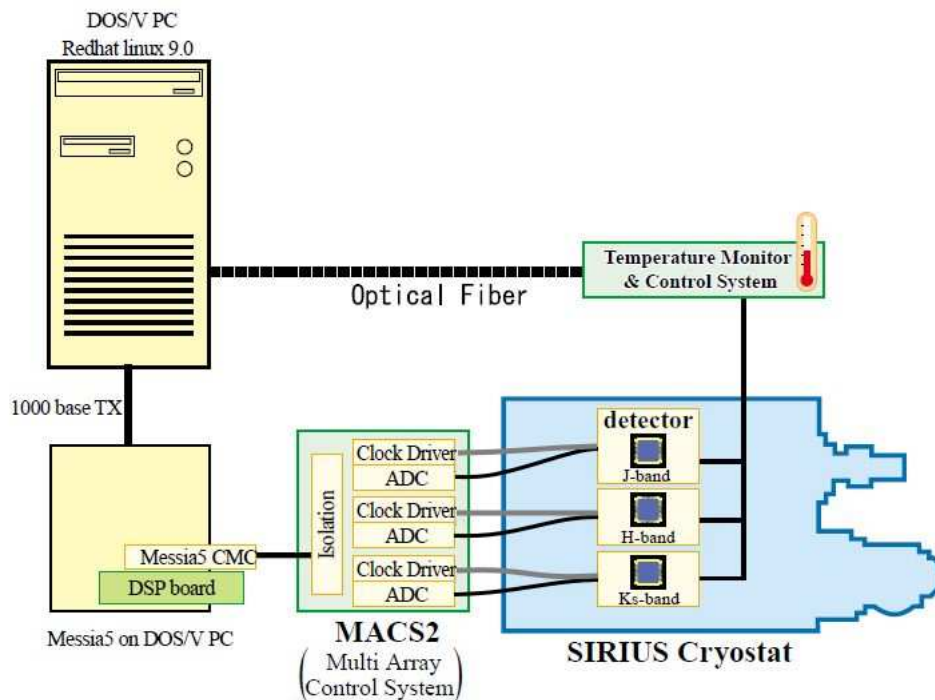
In the block diagram below (Fig. 2) it can be seen that the three channels (bands) are all identical. The output of each detector connects to its own ADC-module and each channel is clocked by its own Clock Driver board. This means that faults can be traced by swapping cables between channels and by noticing how this affects the resultant image, deductions can be made whether the fault is inside the cryostat, in the wiring or with any of the modules.

Fig. 2 Block diagram of the SIRIUS instrument

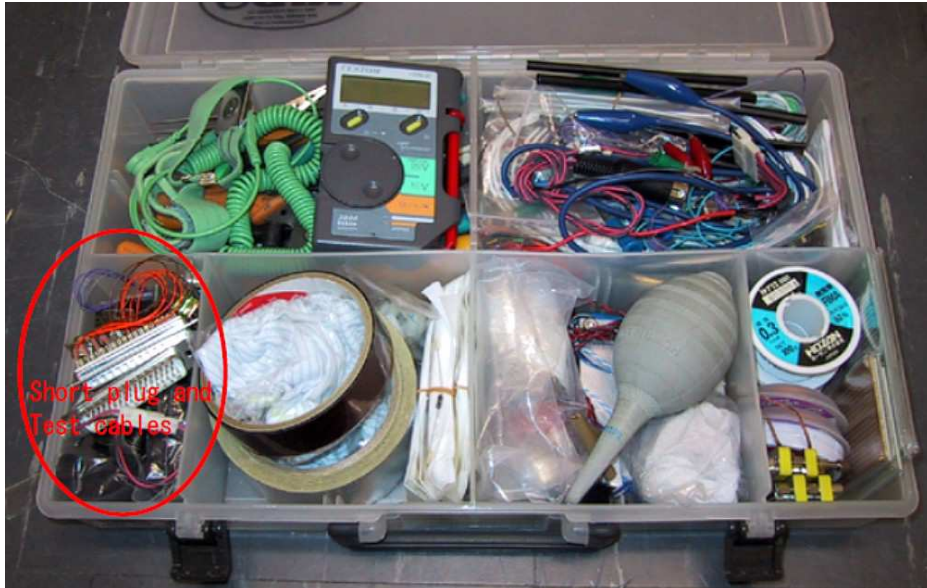
Locate the SIRIUS Toolbox (Fig. 3), kept under the camping table in the control room and identify the relevant items shown in Fig. 4 below.

Fig. 3 The SIRIUS Toolbox

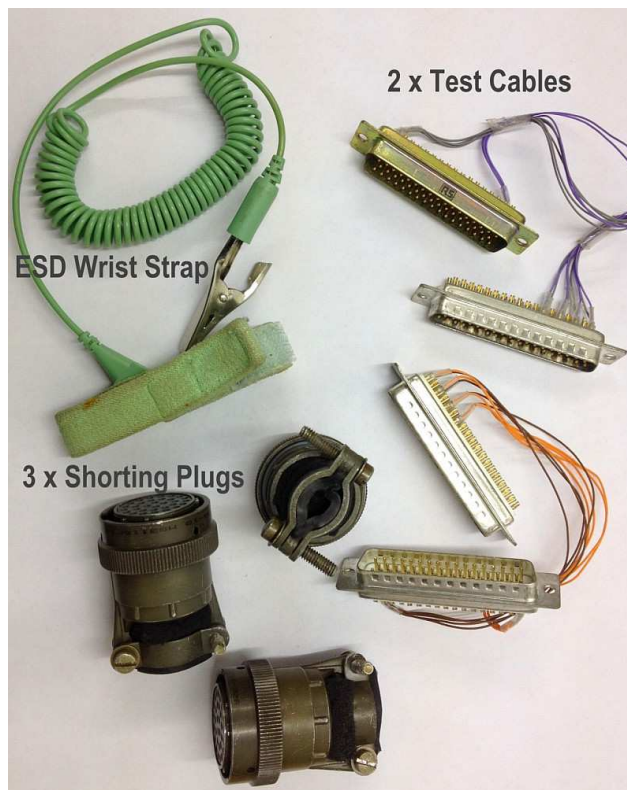
Fig. 4 The relevant items (from the SIRIUS Toolbox) required for these tests

1. Always switch off detector power at the two Kenwood PSUs before disconnecting or reconnecting any cables.
2. Static can destroy a detector, so use ESD protection throughout, i.e. always use a conductive wriststrap (Fig. 4) connected to the instrument earth and discharge yourself to the instrument potential by touching it with both hands before connecting or disconnecting any cables.
3. When unplugging the connectors on the instrument itself (mil-spec connectors, plugging into the vacuum-wall plugs), terminate the vacuum plugs as soon as possible, using special shorting plugs (Fig. 4).

All work should be done with ESD protection. Please use the wrist strap for ESD (Fig. 4).

1. Short Plug (see Fig. 4):

This is a plug for the ESD protection of detector during the cable is unplugged. Just the instrument side connector with conducting foam. This plug should be attached when the detector cables are unplugged from the instrument.

2. Test cable:

One side is D-sub 50-pin connector, while another side is D-sub 37-pin connector (see Fig. 4). I suppose only two wires are connected to the 50-pin connector. They are both separated into 4 wires and connected to the 37-pin connector. This cable should be used when we operate the detector readout system without the connection to the detector in order to avoid the open input of ADC card. Please connect this cable to the ADC and clock driver if you operate the readout system without the connection of detector. Then the 5V is connected to the ADC input (see Fig. 6).

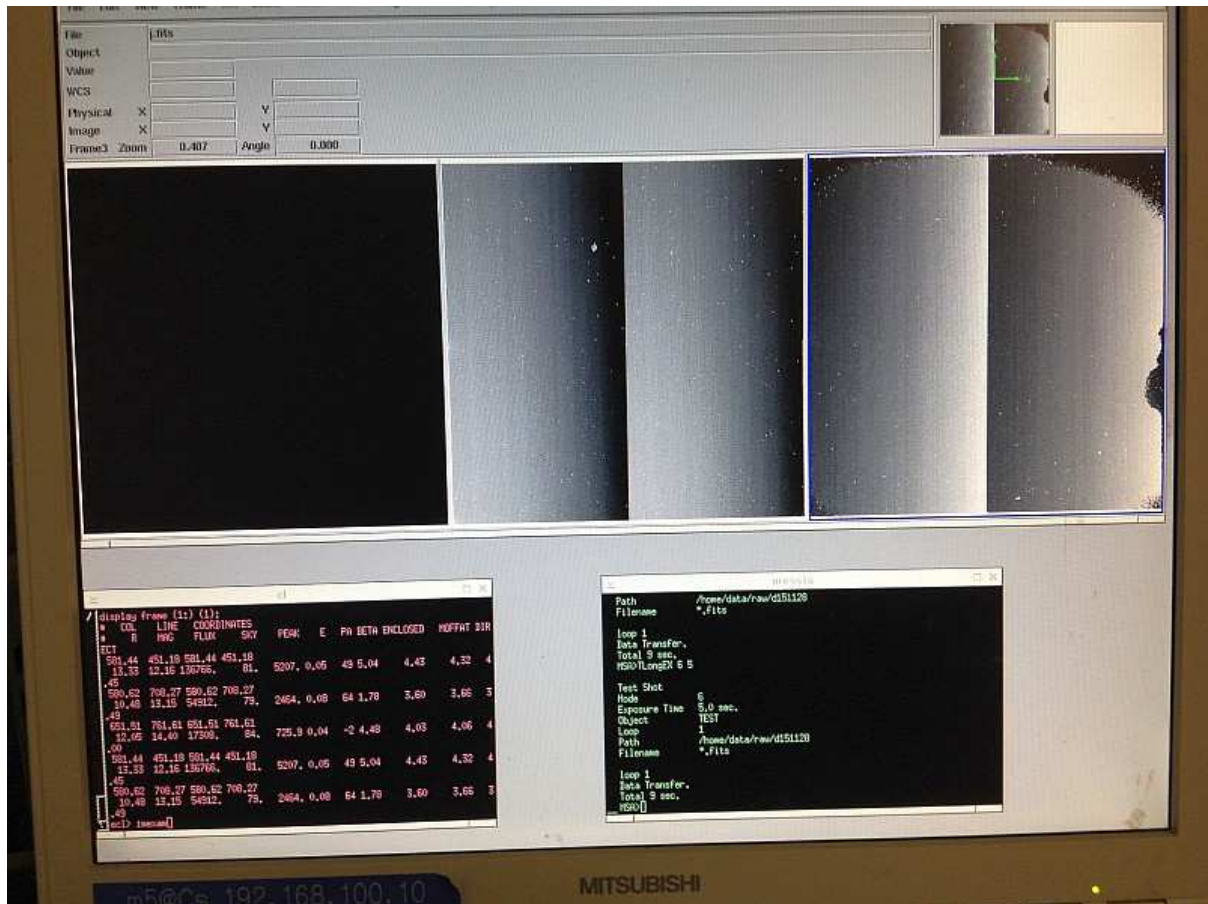
The resulting bias-exposure is shown in Fig. 7. Since the middle (H-band) (now fed by the suspect long loom) is fine, it suggests the long loom is fine and that the fault is inside the dewar.

Fig. 7 Resultant image from the 2nd test described above

The fault eventually disappeared after the instrument went through its full warm-up, re-pump and cool-down cycle, proving it actually was “inside”.
